Manhole Inspection Summary

Manhole # S41CC_034MH

Insp Date: **11/10/08 2:46 PM**

Location Address: **rear 932 n central av**

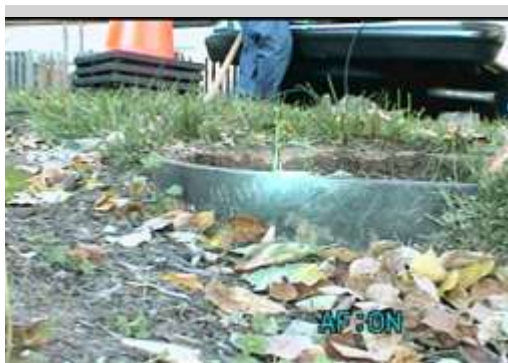
Defect 1

Diameter: **26** (in.) Length: **0** (in.) Dist A/B Grade: **2** (in.)

cover 2 inches above grade

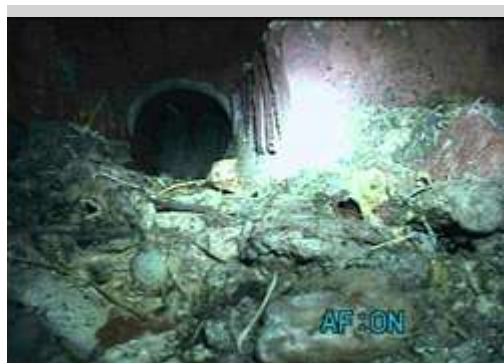
Defect 4

Condition: ☐ Sound ☐ Cracked ☐ Root Intrusion ☐ Deteriorated ☐ Leaks ☒ **Debris**

channel debris

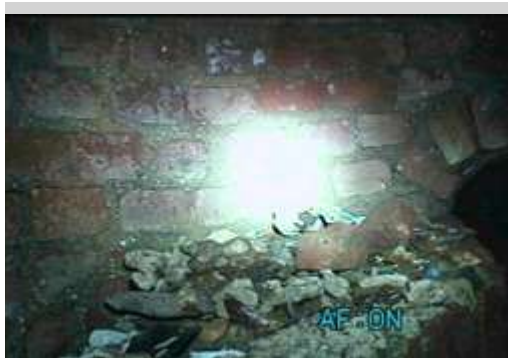
Defect 3

Condition: ☐ Sound ☐ Cracked ☐ Root Intrusion ☐ Deteriorated ☐ Leaks ☒ **Debris**

bench debris

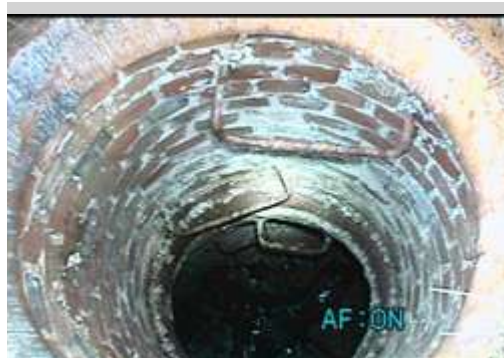
Defect 2

Count: **6** Missing: **0** ☒ **Corroded**

steps corroded
